URGENT SAFETY ALERT

SCAFFOLD STAIR FAILURE

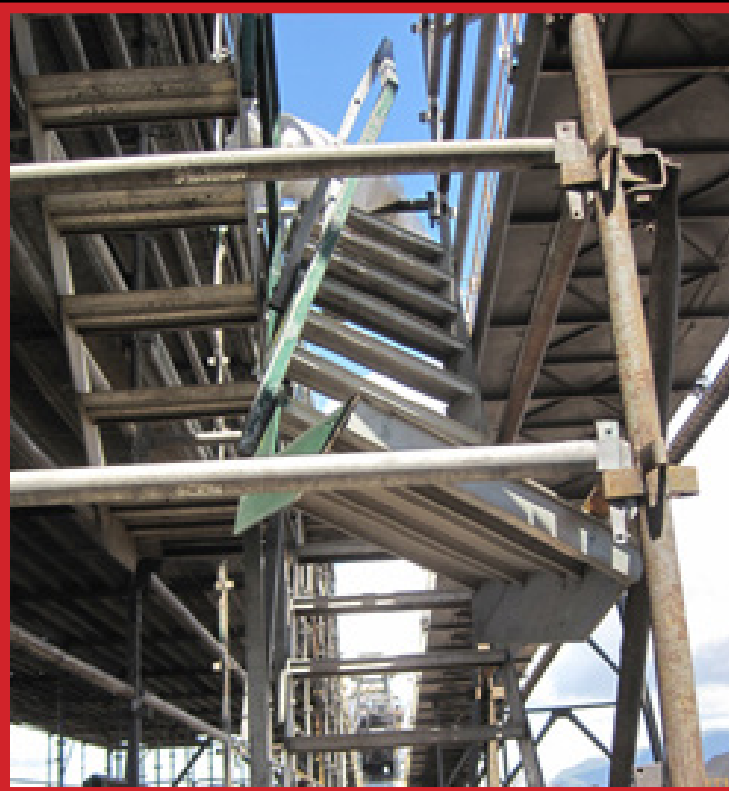
Please undertake a site safety audit on ALL Scaffold Stair tread systems. A number of incidents have occurred in Queensland where modular scaffolding stair units have dropped or stair treads have failed.

There are a number of factors that contribute to the risk of stair modules falling off the supporting transoms, including the following:

- Inadequate support provided by the scaffolding transoms underneath both ends of the stair module, for the width of the module. In other words, the gap between the end of the module and the vertical face of the transom is too big (see Photograph 4) – often caused by the stair module being too short or the scaffolding not being square.
- Insufficient welds being located at critical points of the stair modules – often due to ‘tack’ welds being used instead of continuous or stitch welds (see Photograph 3).
- Stair modules, including welds, being damaged or cracked – particularly during assembly, dismantling and transport.
- The supporting transoms underneath the stair module being able to twist or rotate – possibly due to loose connections.

Any faulty/inadequate stair tread systems identified through this process should be removed from service immediately.
