## Workplace Health and Safety Queensland

## SAFETY ALERT

### Mobile cranes with a free fall feature

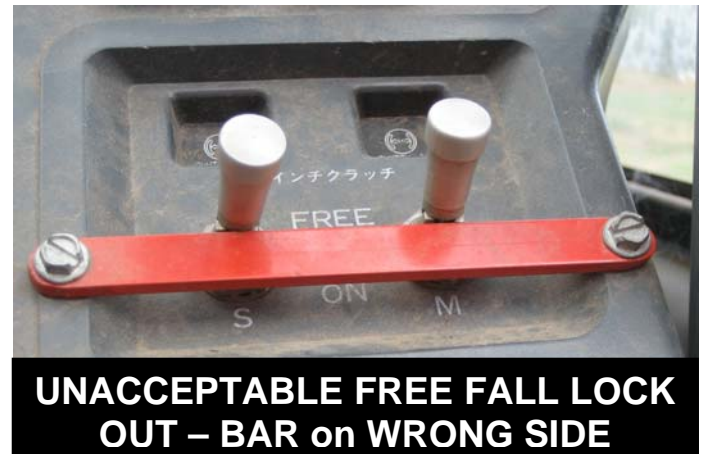
To prevent inadvertent activation of the free fall feature, it is a common practice for crane owners to install a physical lock. Unfortunately, some of the physical lock arrangements have not been effectively installed. Errors have been made when interpreting the operation of the free fall switching mechanism. Photograph 1 shows

one example of the physical lock being fitted to the wrong side of the switch. In this example the crane may inadvertently go into free fall if the hoist brake pedal on the crane is depressed.

**UNACCEPTABLE FREE FALL LOCK OUT – BAR on WRONG SIDE**

**Photograph 1:** Photograph shows an incorrect arrangement of the physical lock on a Tadano TR 200M-5 mobile crane to prevent inadvertent activation of the free fall mechanism where the metal bar has been placed on the wrong side of the switches.

- Owners of cranes with free fall features, that do not have a physical lockout arrangement to prevent inadvertent

activation, are to engage a competent person to install a lockout and test the arrangement.

- Owners of cranes with a free fall lockout on the crane are to engage a competent person to inspect and test to ensure that the lock out has been correctly installed and free fall cannot be inadvertently activated.

The test of the free fall function (while the lock is installed) is to verify that free fall cannot be inadvertently activated. The test is to be carried out in a controlled environment where people cannot be injured and the crane cannot be damaged. A signed, written record of the test is to be provided on the crane.

- Owners of any crane with free fall capabilities should consider de-activating the free fall facility permanently unless there are no alternatives for this type of operation. A documented risk assessment should be prepared for this situation. This de-activation of the free fall should include removal of free fall switches on the crane and a certificate from the crane manufacturer or a competent person (preferably a professional engineer) to state that the free fall function has been permanently removed.
