Soft Sling fatalities

State-wide alert on round slings

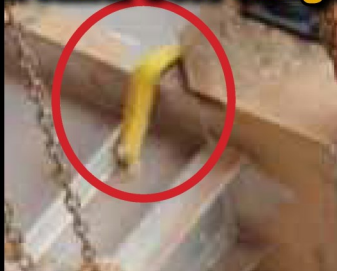
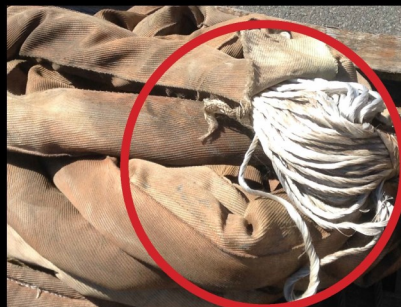
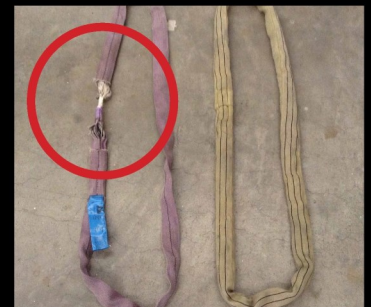
Examples of broken soft slings

Evidence of external wear such as abrasion or cuts and contusions, internal wear which is often indicated by a thickening of the sling, damage by high temperatures, sunlight or chemicals indicated by discoloration, damage to the label and/or stitching are common failures with round slings.

The CFMEU recommends that round slings be removed from service and replaced with alternative products such as Superflex wire rope which is light weight, they are also the ultimate in long life and gripping power, and easy to clean and store.
